## Case 372 : Narrative

Case Vehicle (A): 2001 Ford	Vehicle (B): 1998 Ford
Type: Explorer Sport, 4 x 2, 2-door SUV	Type: Escort SE, 4-door sedan
Driver: 24-year-old male	Driver: 21-year-old female
CDC: 12-FYEW-2	CDC: 11-LDAW-4

This is a fatal crash. The driver of vehicle (B) died as a result of head and neck injuries.

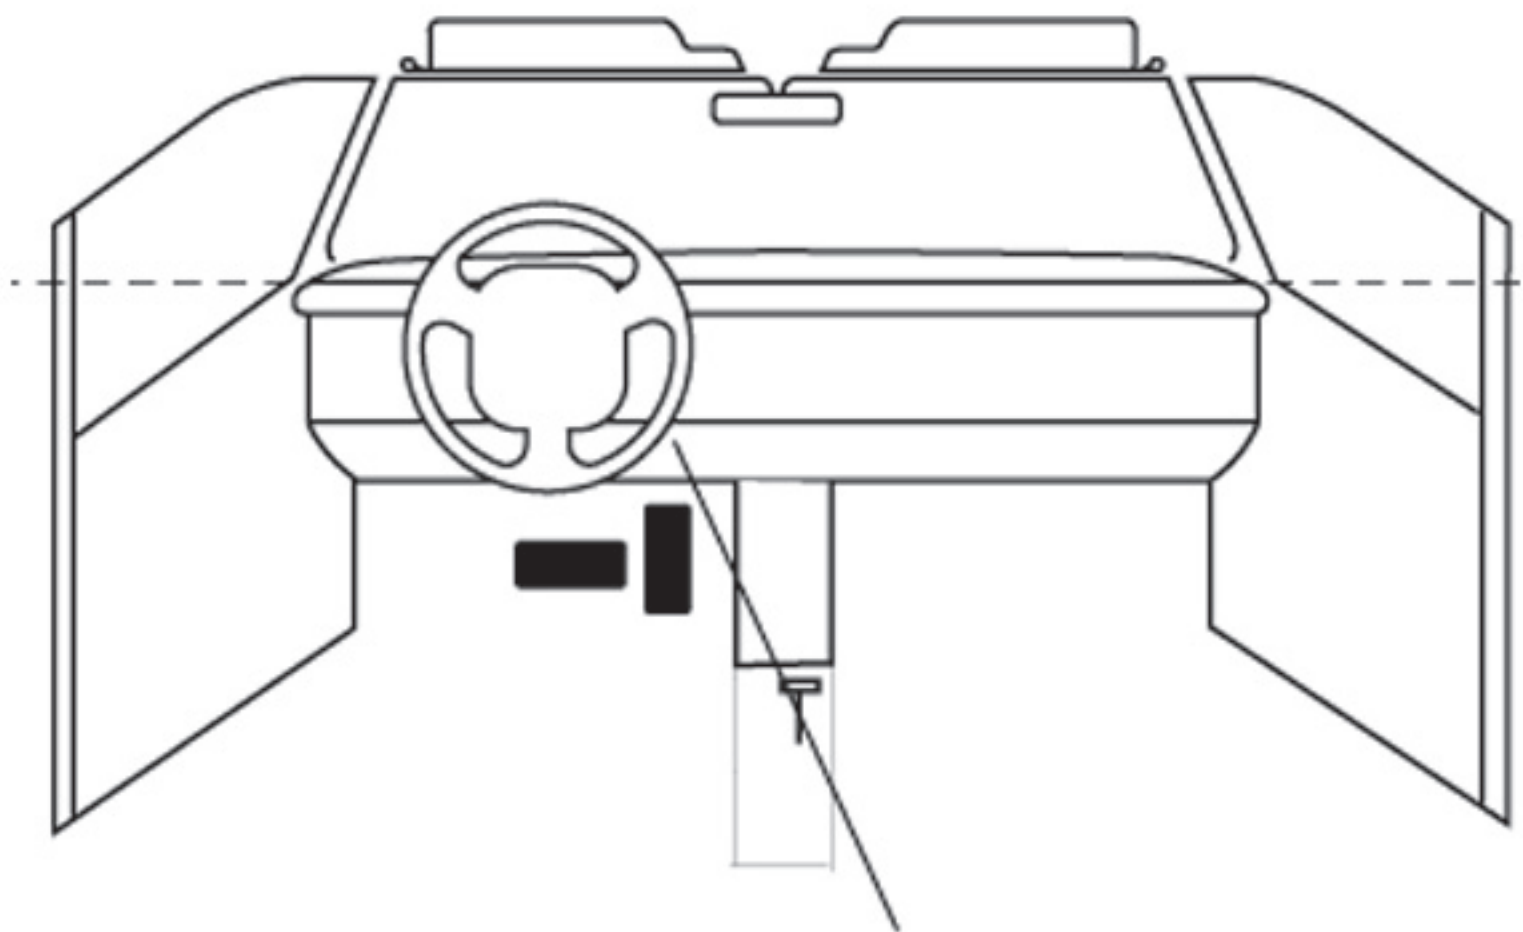
Contact	Interior Component Contacted	Occupant No. if Known	Body Region if Known	Supporting Physical Evidence	Confidence Level of Contact Point
A	Knee bolster	DR	Rt. leg	Scuffmark	1
B					
C					
D					
E					
F					
G					
H					
I

**A = knee bolster,  
scuff mark**

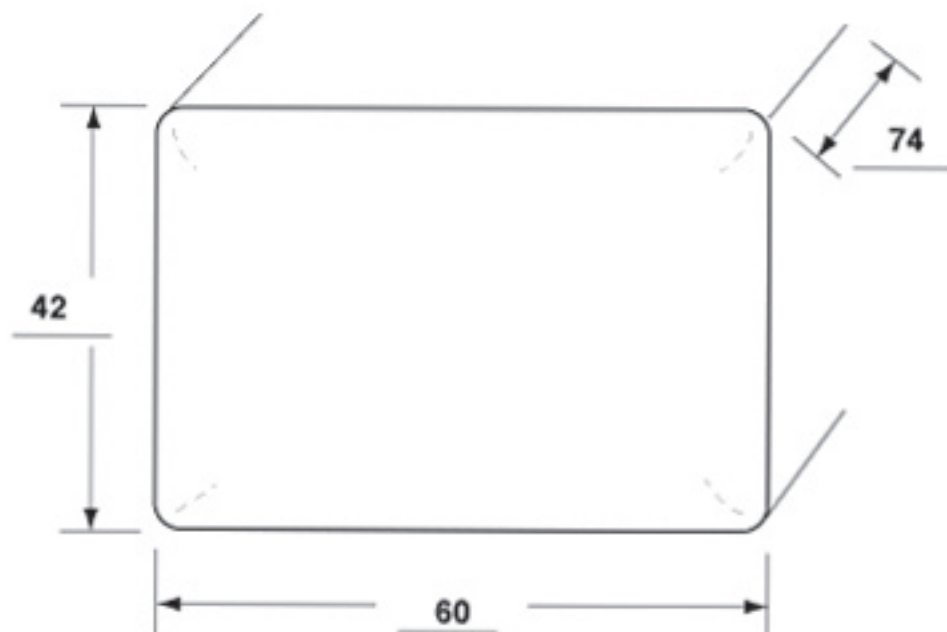
Passenger Airbag

Vents: ☒ Y ☐ N  
if yes, how many: 2  
**3 and 9 o'clock on sides**
